Fox Glen Condominium Association 2015 Drainage System Report

August 2015

DRAINAGE INSPECTION REPORT

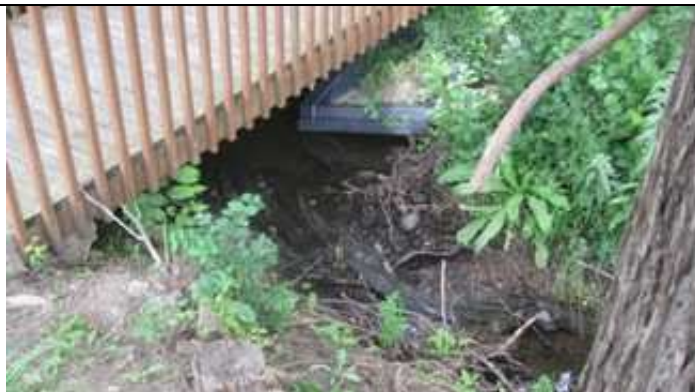
Washout Under Walkway Bridge at Ellsworth Rd.
