**MEMORANDUM**

RE: Fox Glen Subdivision Wetland and Stormwater Review (RZ#10-04)

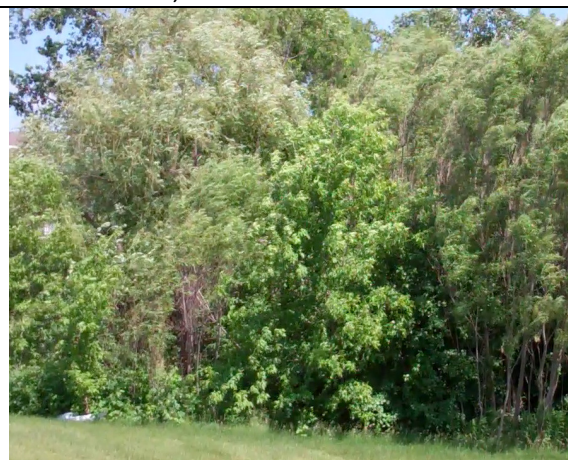
**Wetland 1** is a mainly a wooded wetland with a small area of emergent wetland in the interior. Some of the wooded portion is wetland, and some is upland buffer. This wetland appears to receive drainage from nearby stormwater basins (SW Basin #1 and #2). The drainage flows through a culvert under the street south to Wetland 2. Dominant vegetation in Wetland 1 includes elm (*Ulmus Americana*), black willow (*Salix nigra*), cottonwood (*Populus deltoides*), common buckthorn (*Rhamnus cathartica*), rice cut-grass (*Leersia oryzoides*), and cattail (*Typha angustifolia*). ECT believes this wetland offers valuable functions including wildlife (especially songbird) habitat, nutrient and sediment removal, and stormwater storage.

Wetland 1 with wooded buffer, facing south.

**Wetlands 1 & 2** are regulated by the Township and the Michigan Department of Environmental Quality (MDEQ). ECT does not recommend any cutting of vegetation within wetland boundaries. If stormwater outlets in the wetlands are blocked (ECT does not at this time believe they are), removal of enough vegetation to clear the blockage would be reasonable. Removal of vegetation would require a Wetland Use Permit from the Township. No disturbance of the soil appears to be warranted and is not recommended. Soil disturbance in a regulated wetland would require a permit from the Township and the MDEQ.

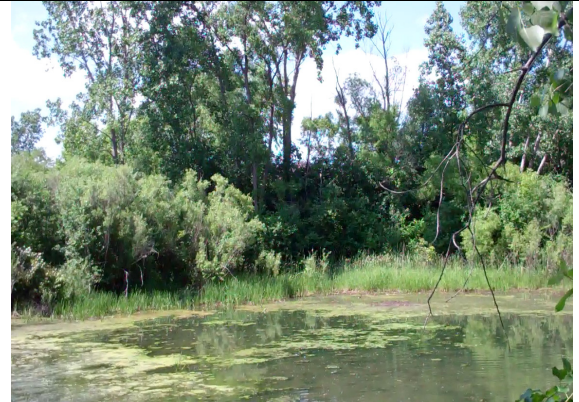
**Wetland 2** is the larger of two wetlands on the property. It is a wetland complex with a ponded portion and a mainly forested portion. Dominant vegetation is similar to that of Wetland 1 with the addition of rushes (*Juncus spp.*), duckweed (*Lemna minor*), and algae found in the open water (ponded) area. Drainage (dashed white line in Figure 1) continues through Wetland 2 and leaves the Fox Glen subdivision and enters a county drain culvert running under Ellsworth Road. ECT believes this wetland offers valuable ecological services including urban heat island mitigation, wildlife (especially songbird) habitat, nutrient and sediment removal, and stormwater storage. Given the wetland's attributes, ECT does not recommend any more vegetation trimming than what is necessary to keep sidewalks clear.

Wetland 2 ponded area and woodland buffer, facing north.

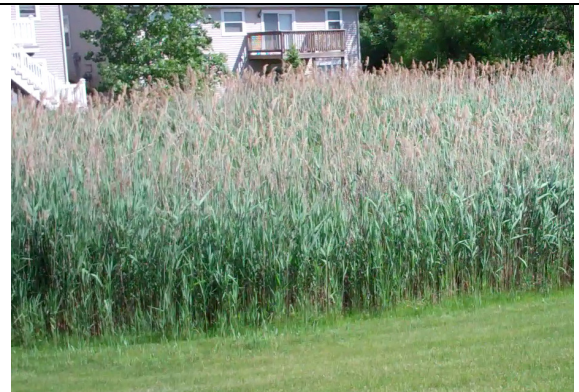
**SW Basin 1** is thickly vegetated almost entirely by common reed (*Phragmites australis*), which is a non-native invasive species. Considerable plant biomass has accumulated in the basin, reducing some of the basin's storage capacity.

SW Basin 1 full of Phragmites, facing southeast.

**SW Basins 1, 2, 3, and 4** are heavily vegetated and would benefit from trimming some of the thick reeds, cattails, and woody plants from around inlet and outlet structures. The common reed (Phragmites) and cattails can be cut periodically, for example, annually, to prevent build-up of biomass and maintain optimum storage capacity. The cutting of vegetation above ground level within the stormwater basins does not require a permit from the Washtenaw County Water Resources Commission (Mr. Scott Miller, personal communication June 20, 2011), or the MDEQ. A second option would be chemical treatment of the Phragmites, which requires an Aquatic Nuisance Control Permit through the MDEQ. Or, the homeowners association could contract with a licensed herbicide applicator, who would obtain the necessary permit.

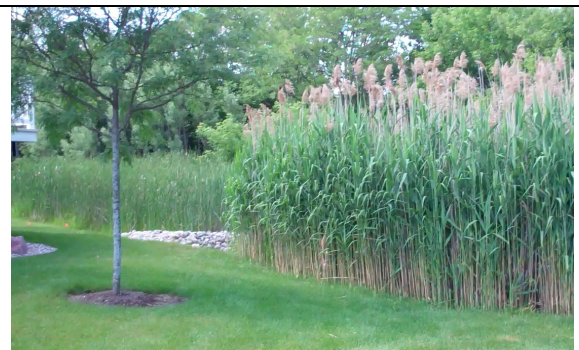
**SW Basin 2** is thickly vegetated with cattail (*Typha angustifolia*), and Phragmites. Like SW Basin 1, it has accumulated a significant volume of biomass, which, on the one hand, helps absorb and filter runoff, but also can diminish storage capacity and restrict flow. Some cottonwood and willow tree saplings are becoming established in this basin.

SW Basin 2 with dense cattails (L) and Phragmites (R), facing north.

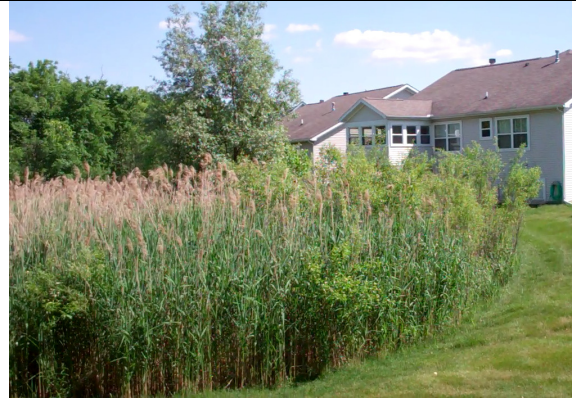
**SW Basin 3** is similar to SW Basin 1 in that it has a thick stand of Phragmites. Willow and cottonwood saplings are becoming established around the perimeter of the basin.

SW Basin 3 with Phragmites and willows, facing south.

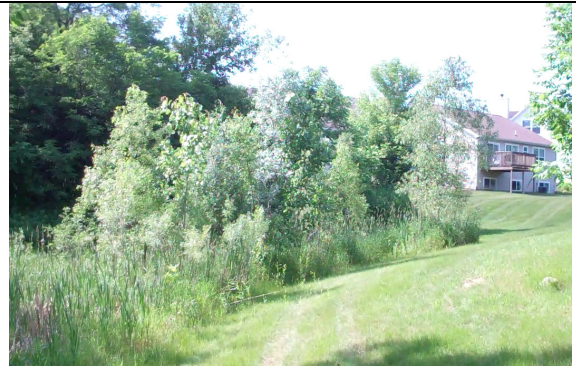
**SW Basin 4** is the most “naturalized” of the stormwater basins at Fox Glen, resembling natural wetland habitat. The basin contains a variety of vegetation, including grown trees such as cottonwood, black willow, and boxelder.

SW Basin 4 with Phragmites, willows, and cottonwood saplings, facing northwest.

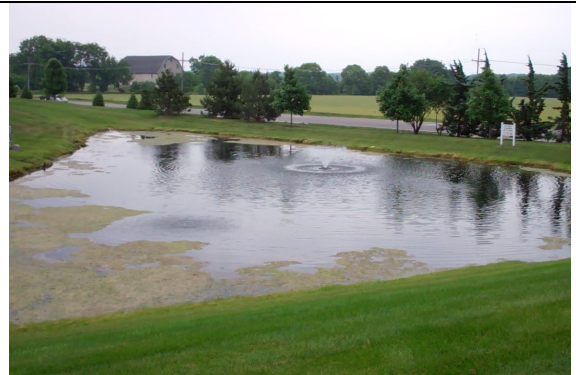
**SW Basin 5** is an open water pond with a fountain at the southeast corner of the property. The pond appears to be mowed up to the water’s edge, which is not the preferred practice. A vegetated buffer left mostly un-mowed would help to filter runoff and absorb nutrients from surrounding turfgrass lawns. A “naturalized” un-mowed buffer would also discourage use of the pond by geese.

Photo 8. SW Basin 5 facing southeast (ECT June 20, 2011)

**SW Basin 5** (Photo 8) would benefit from a naturalized buffer around its perimeter. The buffer would take up nutrients found in lawn runoff, help trap sediment, provide songbird habitat, and discourage use by geese. The buffer vegetation would ideally consist of a variety of native perennial herbaceous plants and shrubs.

4. ECT supports a planting plan for the perimeter of **SW Basin 5**.
5. Chemical treatment of Phragmites in the stormwater basins is an option available to the homeowners association. Information regarding the MDEQ Aquatic Nuisance Control Permit is available on their website: [http://michigan.gov/statelicensesearch/0,1607,7-180-24786\\_24787-245049--,00.html](http://michigan.gov/statelicensesearch/0,1607,7-180-24786_24787-245049--,00.html)

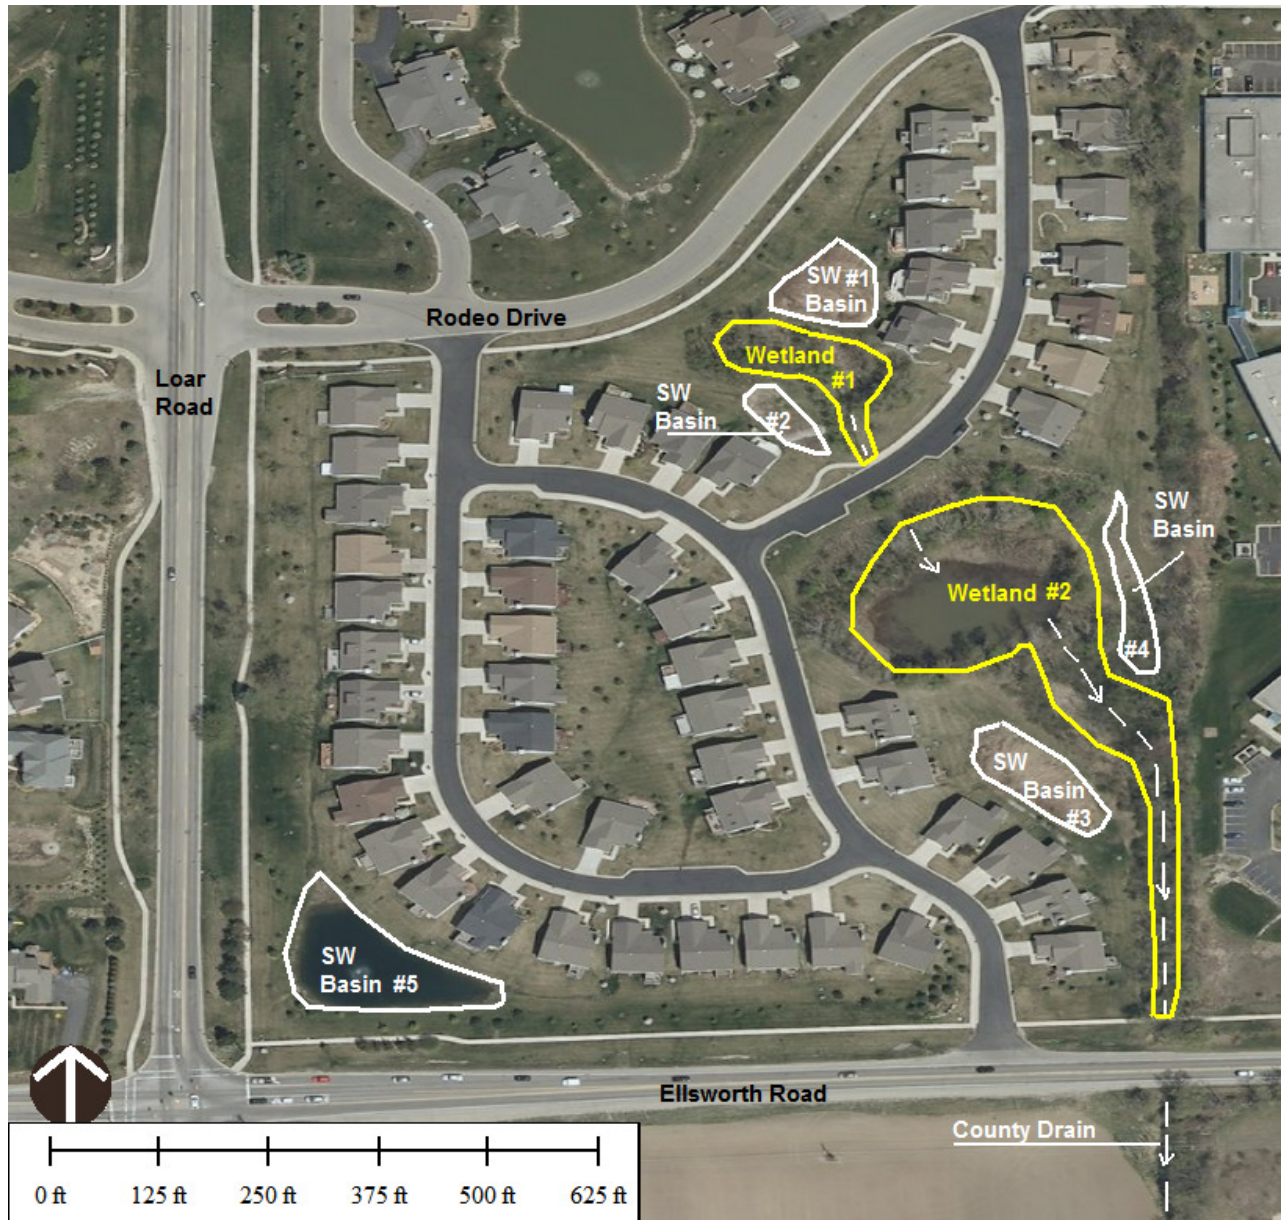
Areal locations of wetlands and stormwater basins are shown in Figure 1.

Figure 1. Aerial view of Fox Glen subdivision's stormwater basins (SW Basin) and wetlands.
